Dysfunction of the Prosthetic Valve : How to Evaluate

Dimitrios M. Farmakis
Cardiology Department
"Papageorgiou" General
Hospital of Thessaloniki

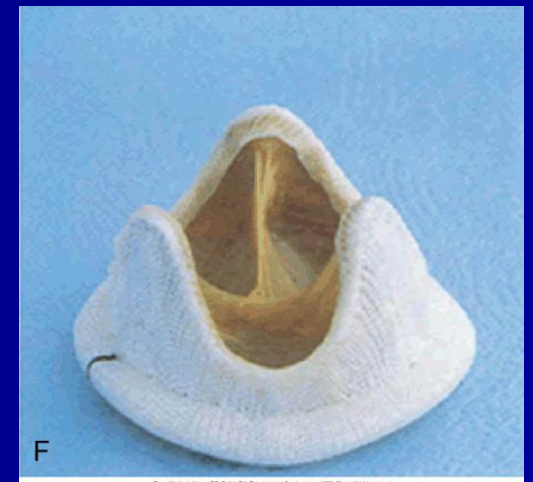
Figure 1. Different types of prosthetic valves. A, Bileaflet mechanical valve (St Jude); B, monoleaflet mechanical valve (Medtronic Hall); C, caged ball valve (Starr-Edwards); D, stented porcine bioprosthesis (Medtronic Mosaic); E, stented pericardial bioprosthesis (Carpentier-Edwards Magna); F, stentless porcine bioprosthesis (Medtronic Freestyle); G, percutaneous bioprosthesis expanded over a balloon (Edwards Sapien); H, self-expandable percutaneous bioprosthesis (CoreValve).

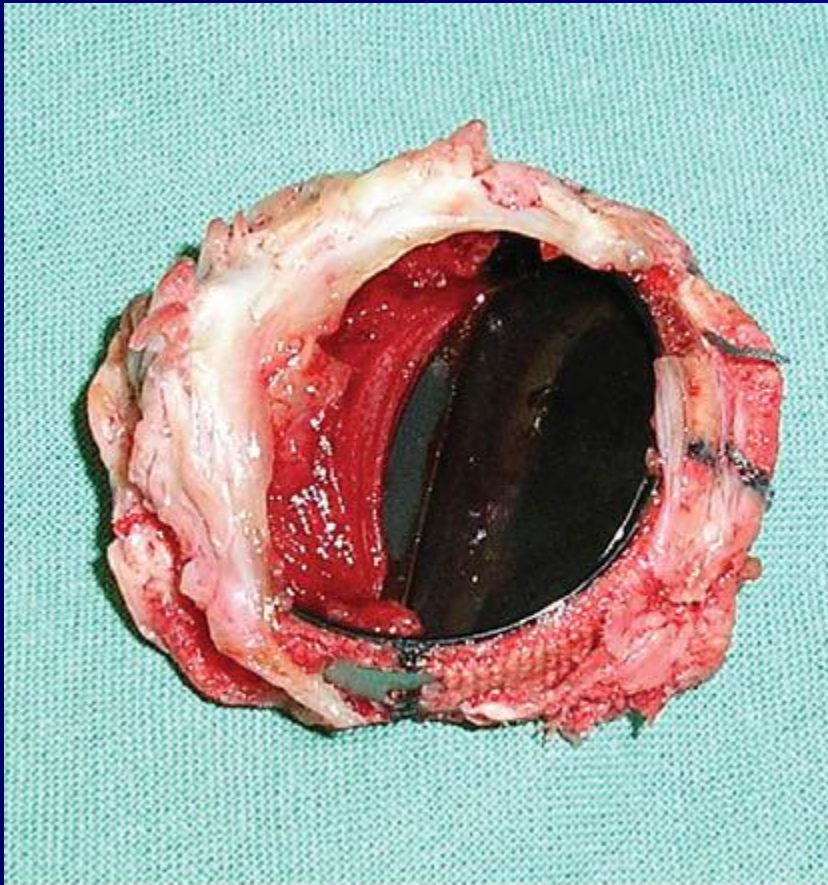
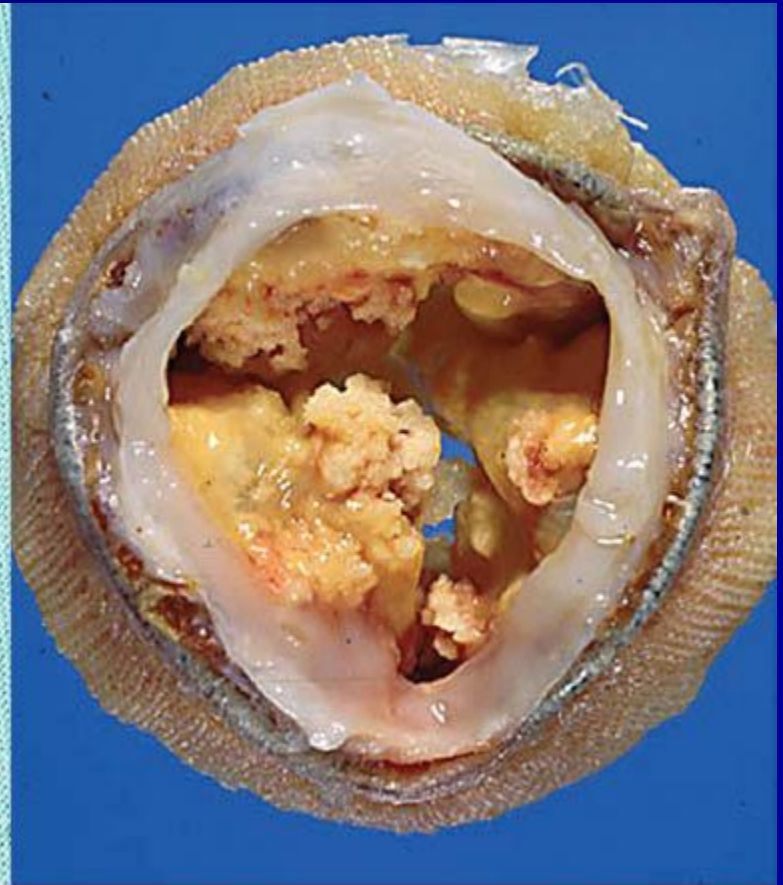
Pannus

- The slow ingrowth of fibrous tissue over the sewing ring in both mechanical and bioprosthetic valves.
- This abnormal overexuberant fibrous reaction usually develops over many years and may interfere with occluder/leaflet motion and narrow the inflow orifice of the prosthesis.
- Secondary thrombus formation can also occur.

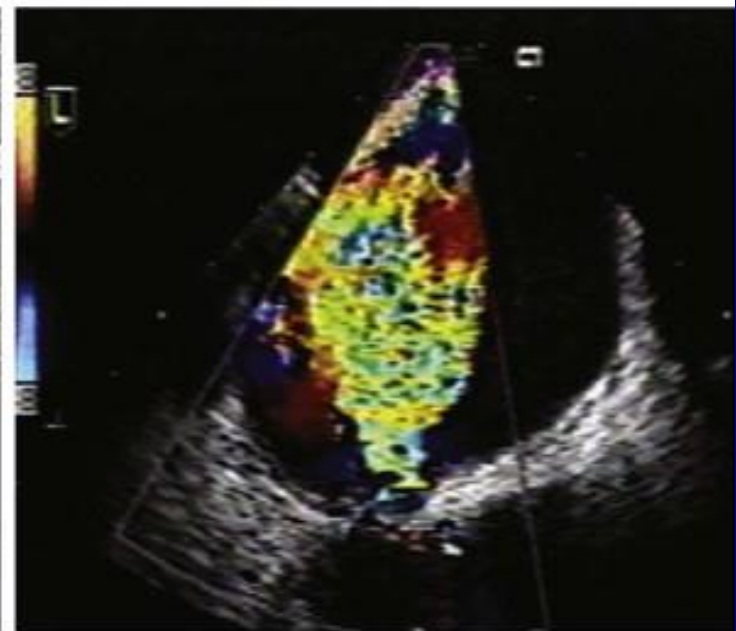
CW-Pr MV

PW - LVOT

$TVI_{MV}/TVI_{LVOT} = 3.7$
